Site Inspection Report

Orderville, Muddy Creek Gemstone Leases: ML 26996, ML 27618, ML 41355, & ML 47588

August 23, 2001

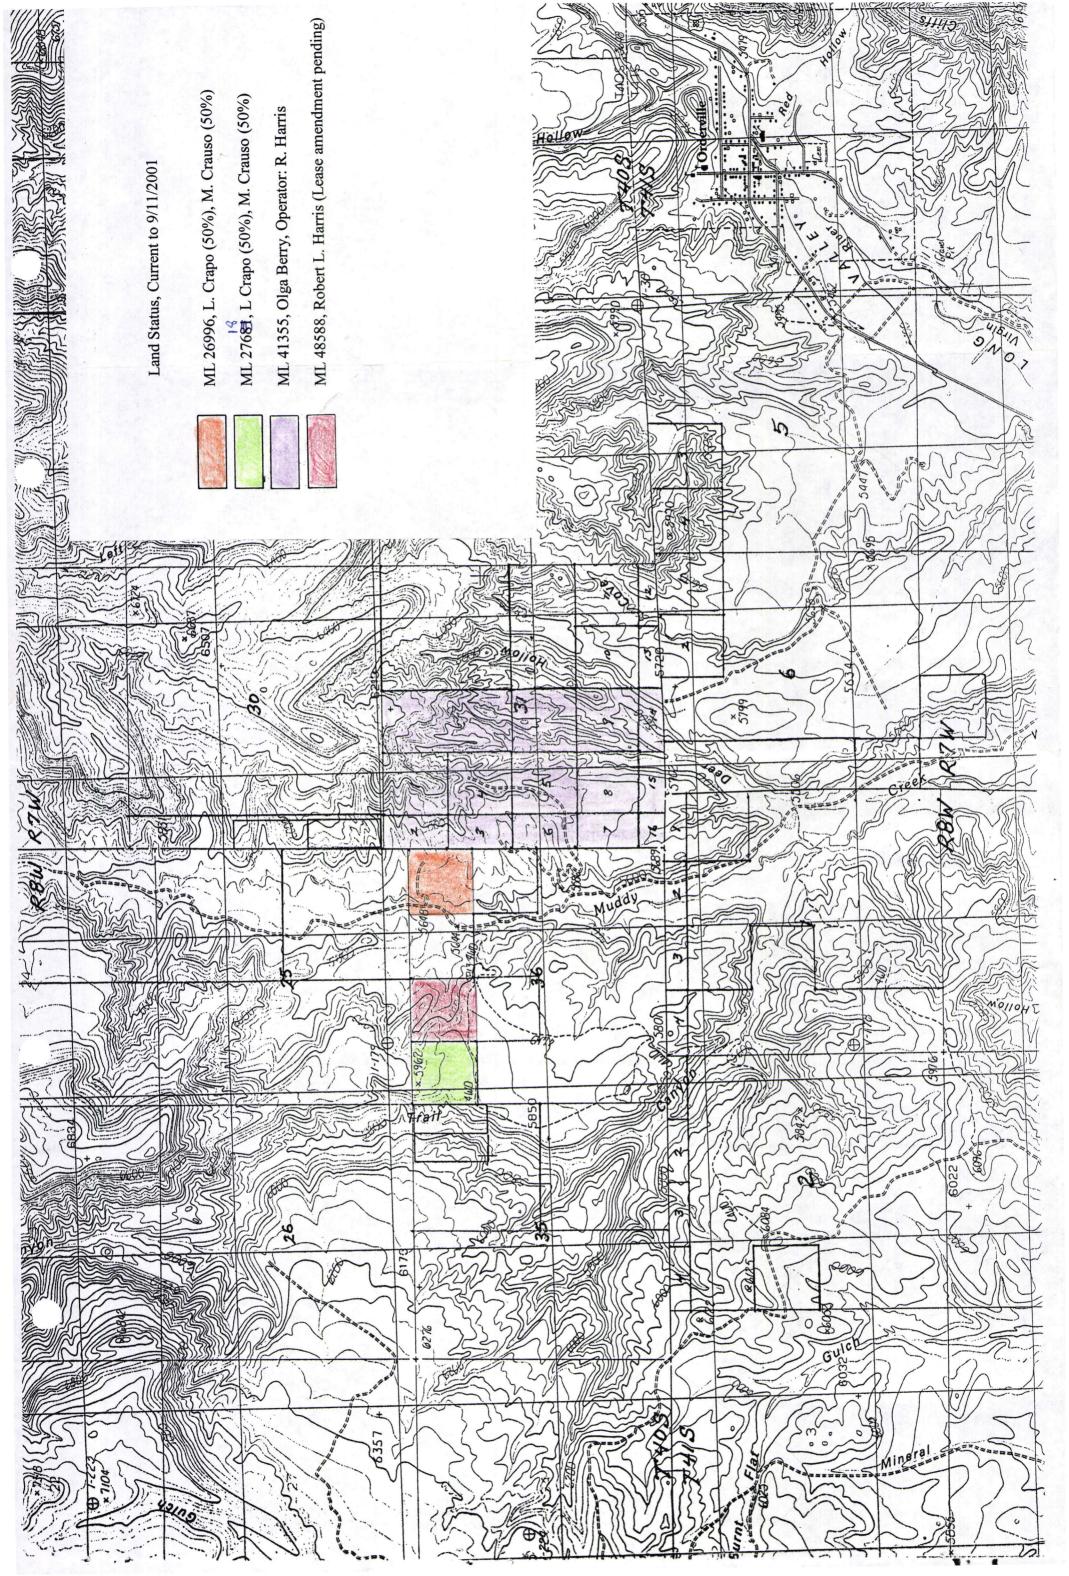
Photograph # 7

Lease ML 48588, NE¼NW¼, of Section 36, T. 40 N., R. 8 W, Lessee: Robert L. Harris. The lands encompassed by this lease were formerly held under ML 19890 which included all of the E½NW¼ of Section 36. ML 19890 was cancelled for nonpayment of rentals on March 15, 2000. Prior to cancellation of ML19890, and as reported in the June 13, 2000 site inspection report, there were 2.71 acres of un-reclaimed surface disturbance and 1.87 acres of mined land that had been graded and seeded. The recent mining activity, under lease ML 48588, has disturbed approximately 3.37 acres of land, one acre of which overlaps the previous un-reclaimed surface disturbance. Total acres of un-reclaimed mined land, including the active quarry site and the associated overburden dump, is 5.09 acres. See photographs 6 and 7 of this report.

Looking west into the 2001 quarry site on lease ML 48588. Using the human figure standing on the top of the pit wall the wall height can be estimated to be approximately 40 to 50 feet high.
